CASE STUDY

Water Efficiency at 80 Mooregate

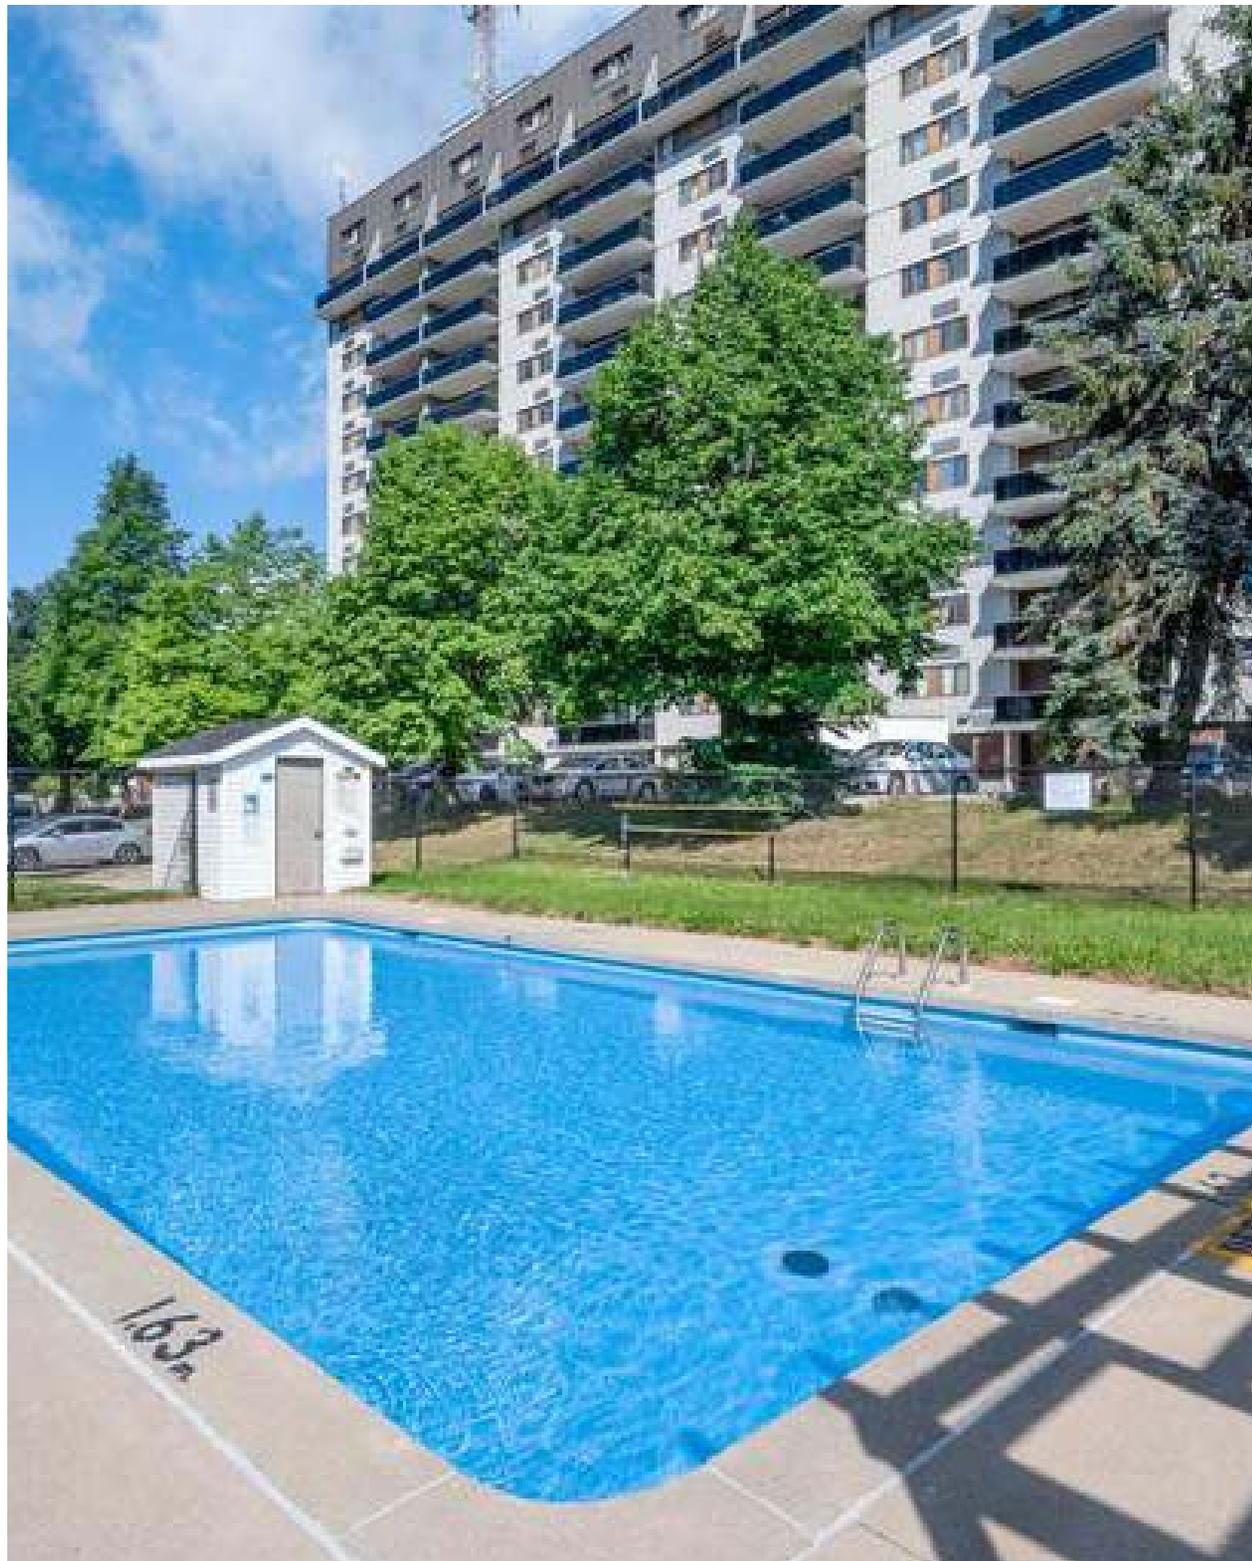
With SensorSuite's WaterLink, the pulse output meter generates readings every minute to allow stakeholders to gain a more detailed understanding of the building's performance. By analyzing the hourly data of minimum, peak, and average consumption, it was determined the minimum consumption per unit at 80 Mooregate was significantly higher compared to 66 Mooregate. The daily average per unit consumption was 0.72 m^3 compared to 0.57 m^3 . The assumption was there were significant leaks contributing to the high consumption. With the available data, it encouraged Hazelview Properties to complete a full water retrofit for the building.

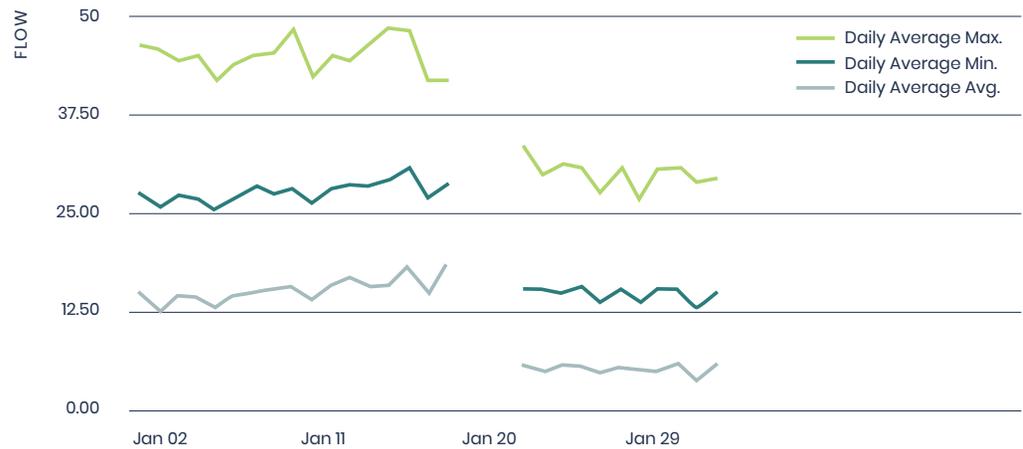
80 MOOREGATE DAILY FLOW: PRE- AND POST- RETROFIT

The retrofit was completed from October 18th - October 20th for each suite at 80 Mooregate which included replacement of low cost internal toilet components (flapper, etc.) to minimize leakage, and low flow showerheads and faucet aerators to achieve greater savings. As a result, the minimum, maximum, and average flow rate decreased significantly as shown in the graph on the right.
